101-43-25  
5-3-73

Name \_\_\_\_\_ Catalog No. 101-43-23  
 Latitude N 55° 23' 26" WR No. \_\_\_\_\_  
 Longitude W 131° 17' 3" K No. --  
 Geodetic Map No. Ketchikan - B-4 Work Area Ketchikan  
 Location W. of Mink Islands Watershed Length 1-1/4 miles  
 Drainage Area of Watershed \_\_\_\_\_  
 Water Supply Type Runoff

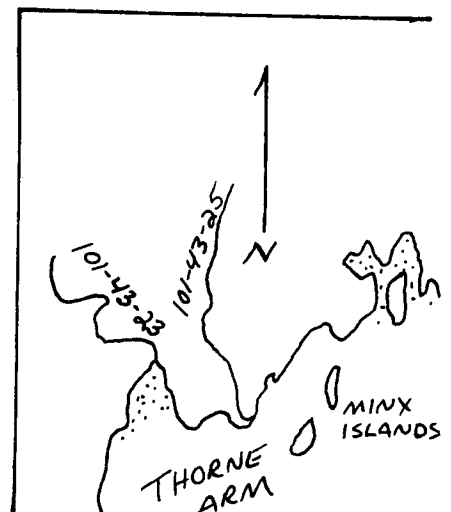
- 103 -

Grassy banks - low  
gradient area -  
possible goose  
nesting area.

This portion of stream is slow moving  
slough type area - some limited beaver  
sign.

Area above station #6 should be looked  
at later with helicopter - we ran out  
of time.

Very poor timber in this area.

Poor spawning potential in this area.

← Rapid type falls - no barrier.

Traces of bedrock  
throughout area  
surveyed.

← Set minnow trap: bait  
was coho, clams, herring:  
caught 1 cottid.

1 : found stranded pink or  
chum fry here.
